**Technical Service  
BULLETIN**

Title:  
**BENT REAR TAIL GATE**

Models:  
**'05 – '07 Tacoma**

**BODY**  
**B0004-07**

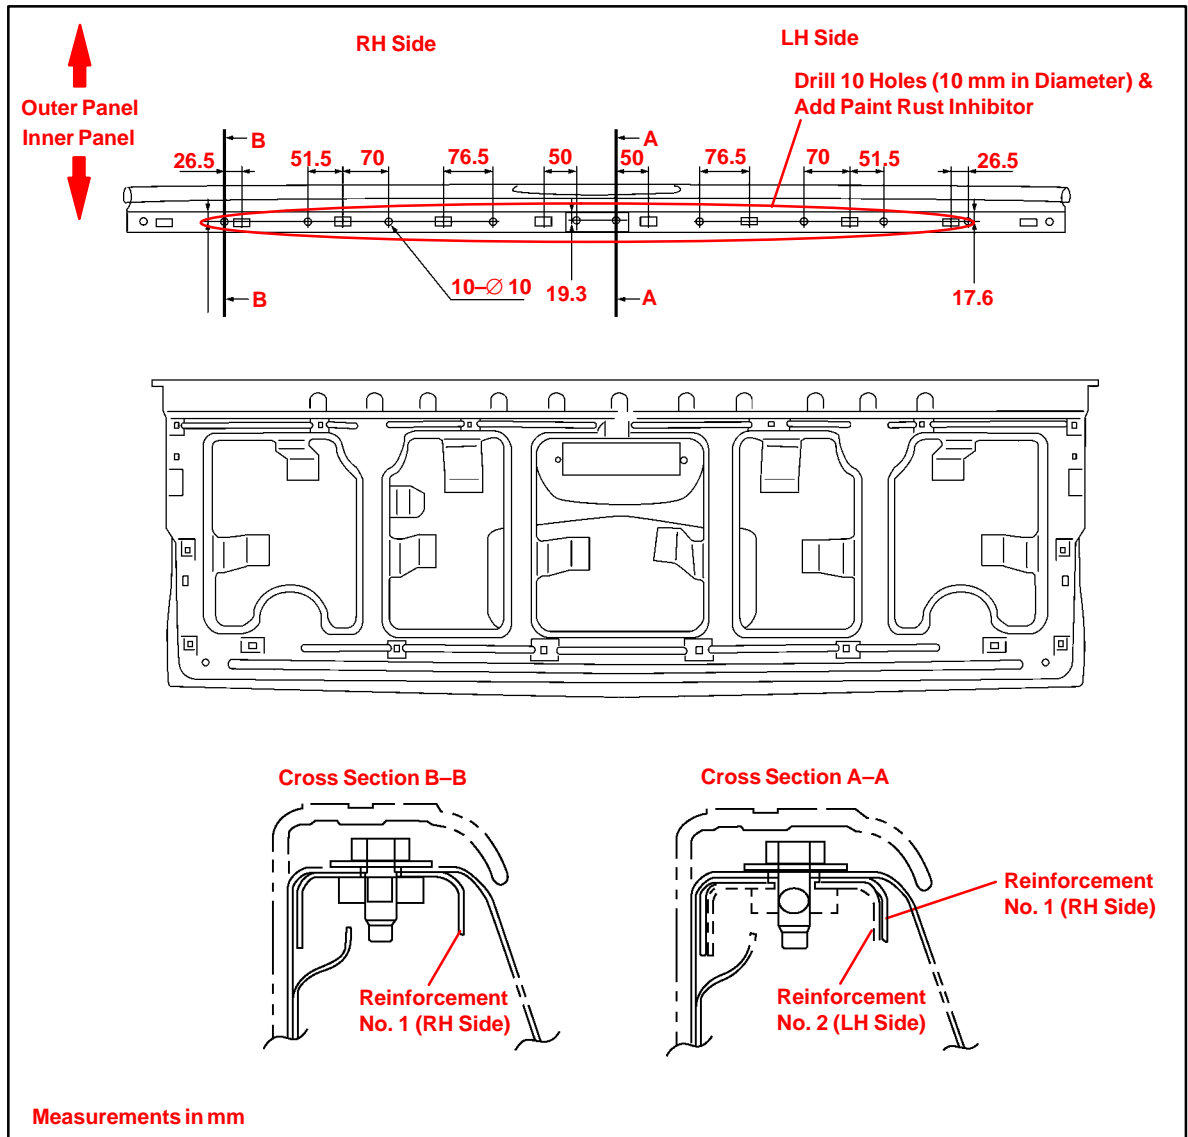
- A. Drill 10 NEW holes (10 mm in diameter). Refer to the following illustration.
- B. Remove any metal shavings from the tail gate with a vacuum.

- C. Apply paint rust inhibitor to the “NEWLY drilled holes” by following the directions on the label described by the manufacturer.
